Inspection Report

Report Date 1/7/2010

| Company | Home Proof Inspections Inc. | Customer | 123 ANYONE |

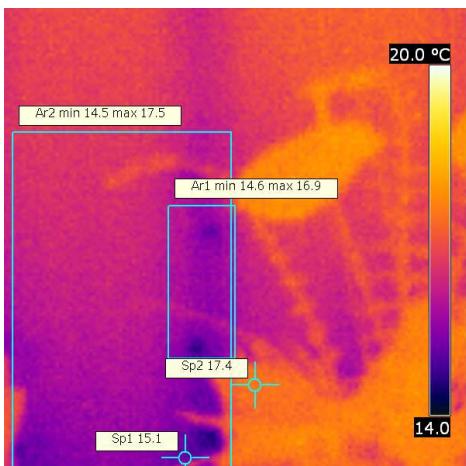
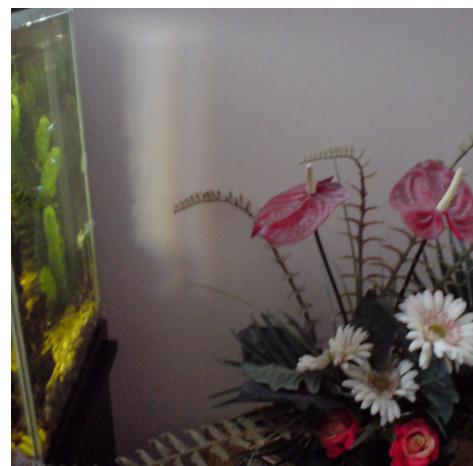
| Image Name | IR_0019.jpg |

| Camera Model | Flir b50 | Basement | Low insulation |

Living room wall, indicates missisng insulation

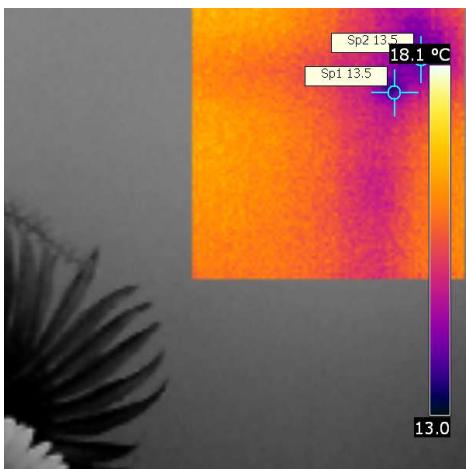
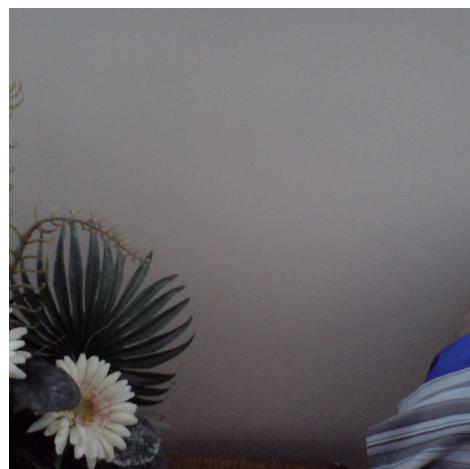
| Image Name | IR_0022.jpg | | |

| Camera Model | Flir b50 | Basement | Low Insulation |

Living room, low insulation

What you see - drywal looks perfectly good

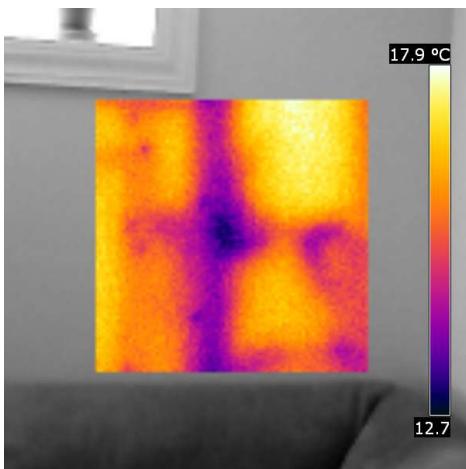
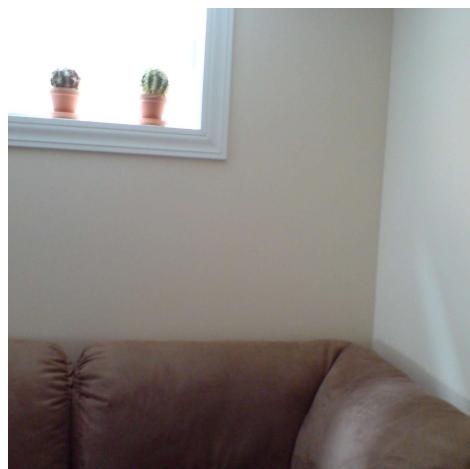
| Image Name | IR_0026.jpg | | |

| Camera Model | Flir b50 | Basement | Low Insulation |

What you see -drywall looks perfectly good

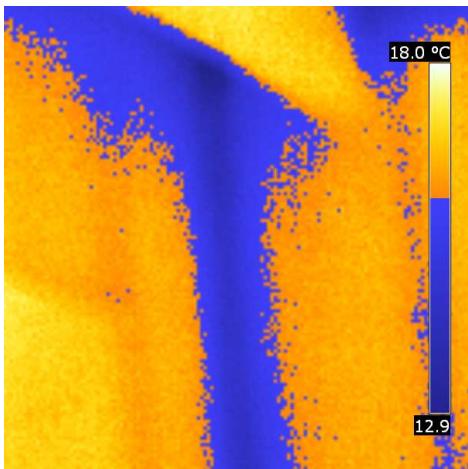
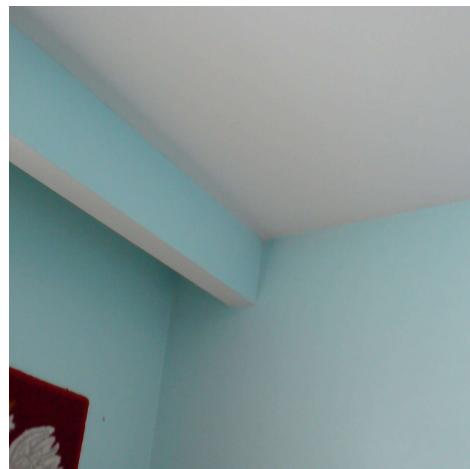
Image Name IR_0054.jpg

Drywall and Ceiling looks perfectly good

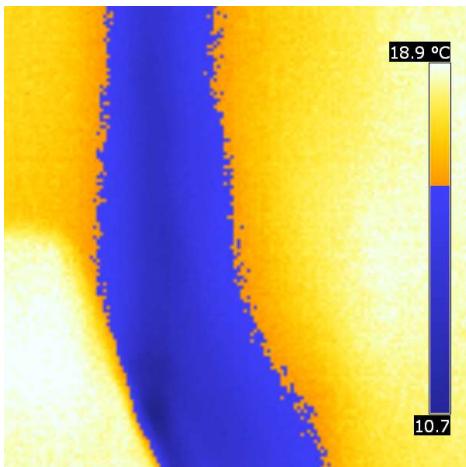
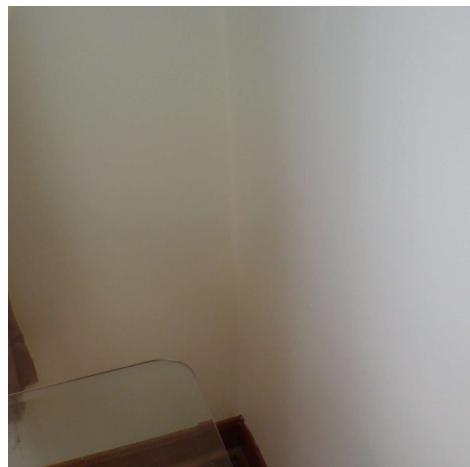
Image Name IR_0058.jpg

Missing Insulation

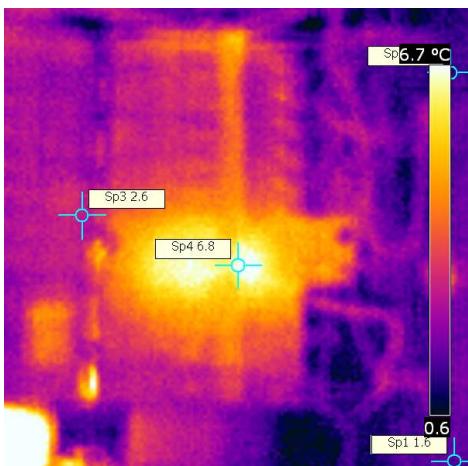
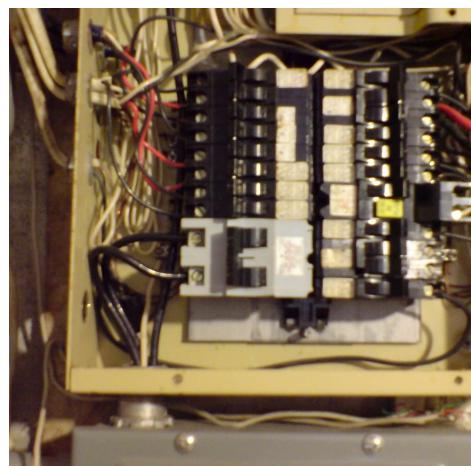
Image Name IR_0042.jpg

Overheated wiring should be corrected by licensed electrician-Fire Hazard

Main Electrical Panel naked eye look OK

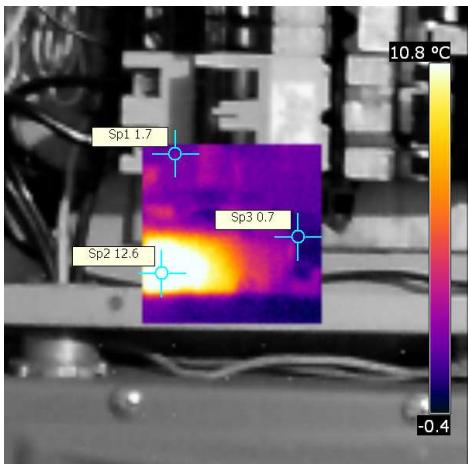
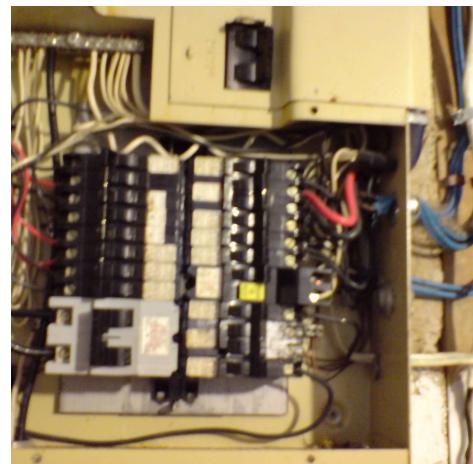
Image Name IR_0038.jpg

Overheated Wiring

Main Electrical Panel Naked Eye looks OK

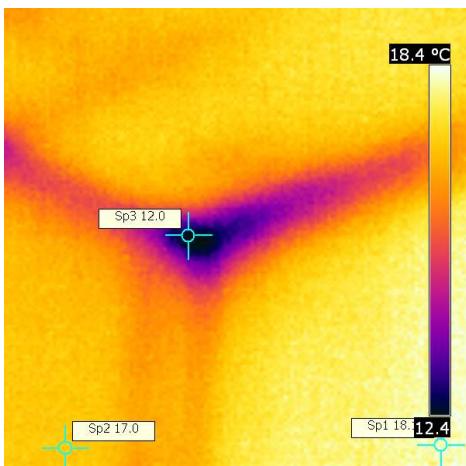
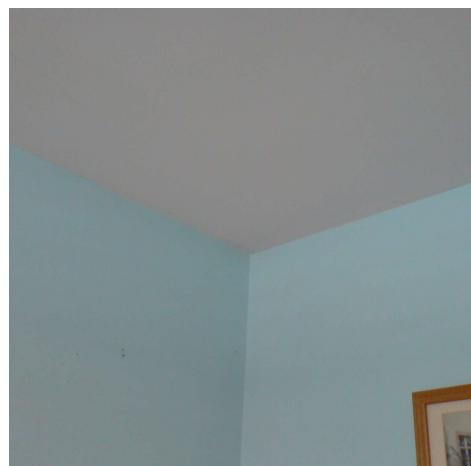
| Image Name | IR_0051.jpg |

| Camera Model | Flir b50 | Living room ceiling missing insulation | Value0 |

| Living room ceiling corner water leaking from roof |

| What you see wall and ceiling looks good |
